**Flood Control Project Maintenance
Levee Inspections**
LMA District Cover Sheet
Spring 2019 Levee Inspection Results

American River Flood Control District

Spring 2019 Levee Inspection Results

Waterway			Bank	Unit Miles
Unit No. 01 Arcade Creek			Left	2.08
	Spring (March - May)	Summer (June - August)	(September - November) Fall	Winter (December - February)
Unit Maintenance Rating (Fall Only)				
Date of Inspection	5/14/2019 - 5/14/2019			
DWR Inspector	Luz Dial			
Accompanied By	Ross Kawamura ARFCD

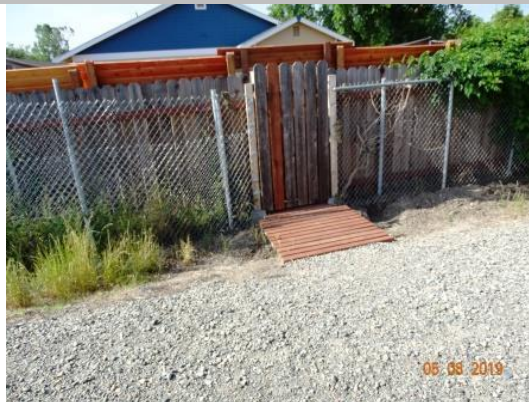
Photo 1 of 2 : SP_2019_NA0001_59_12_20190510_00019.jpg

LM Start	0.38	Rating **	U	Issue No.	12
LM End	0.38	Issue Type +	En	Location *	LS
Category	Earthen Levee			GPS Latitude/Longitude	
				Start	End
Item	Encroachments			38.668149 °	38.668147 °
				-121.440704 °	-121.440533 °
DWR ID	DWR_NA0001_08_f_2018_12				
Comment Code					
FE : Fence					
Inspector Comment					
Wooden fence with vegetation blocks visibility of levee easement. A wooden bridge was built to connect to the levee crown.

View of wooden ramp that connects gate to levee crown. Spring 2019

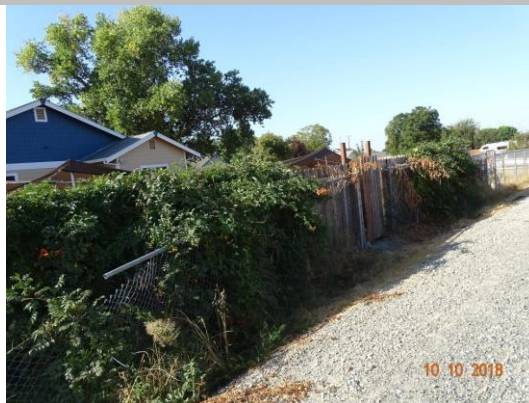
Photo 2 of 2 : SP_2019_NA0001_59_12_20190307_00008.jpg

LM Start	0.38	Rating **	U	Issue No.	12 (cont)	
LM End	0.38	Issue Type +	En	Location *	LS	
Category	Earthen Levee			GPS Latitude/Longitude		
				Start		End
Item	Encroachments			38.668149 °		38.668147 °
				-121.440704 °		-121.440533 °
DWR ID	DWR_NA0001_08_f_2018_12					
Comment Code						
FE : Fence						
Inspector Comment						
Wooden fence with vegetation blocks visibility of levee easement. A wooden bridge was built to connect to the levee crown.

View of wooden fence with vegetation that blocks visibility of levee easement. Fall 2018

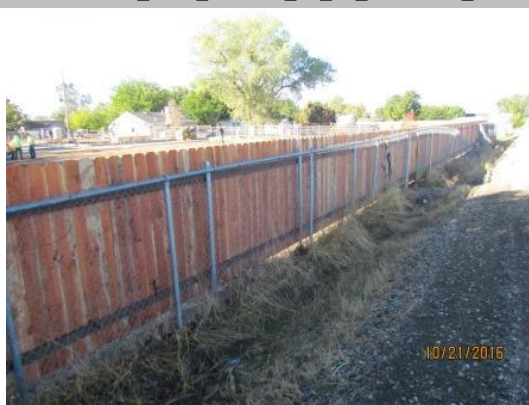
Photo 1 of 1 : SP_2019_NA0001_59_22_20190307_00013.jpg

LM Start	0.39	Rating **	U	Issue No.	22
LM End	0.40	Issue Type +	En	Location *	LS
Category	Earthen Levee			GPS Latitude/Longitude	
				Start	End
Item	Encroachments			38.668145 °	38.668118 °
				-121.440493 °	-121.440268 °
DWR ID	DWR_NA0001_08_s_2014_22				
Comment Code					
FE : Fence					
Inspector Comment					
Fence appears to be constructed at the property line. Fence limits visibility of the landside easement.

View of the wooden fence at the landside levee toe. Fall 2016

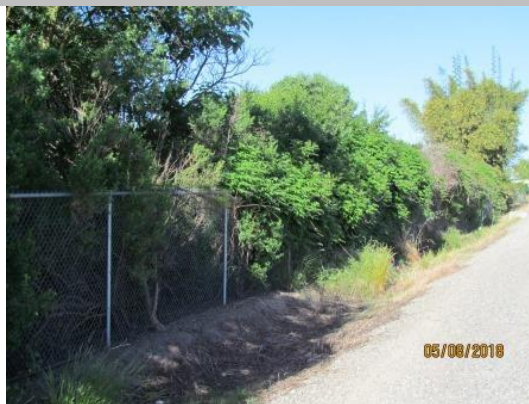
Photo 1 of 1 : SP_2019_NA0001_59_6_20190307_00004.jpg

LM Start	0.40	Rating **	U	Issue No.	6
LM End	0.43	Issue Type +	En	Location *	LS
Category	Earthen Levee			GPS Latitude/Longitude	
				Start	End
Item	Vegetation			38.668147 °	38.668141 °
				-121.440248 °	-121.439755 °
DWR ID	DWR_NA0001_08_s_2012_6				
Comment Code					
V6 : Landscaping					
Inspector Comment					
Vines on fence limit visibility.

View of the vines on fence obstructing visibility of landside toe. Spring 2018

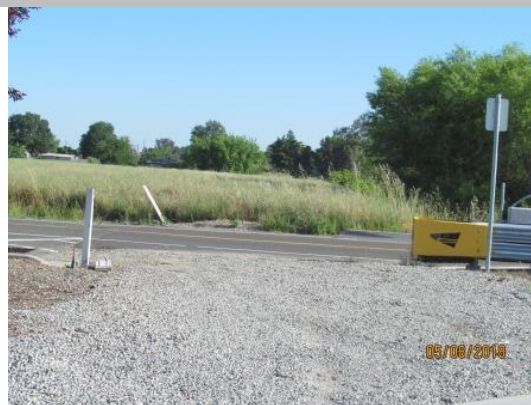
Photo 1 of 1 : SP_2019_NA0001_59_1_20190307_00001.jpg

LM Start	0.51	Rating **	A/W	Issue No.	1
LM End	1.03	Issue Type +	En	Location *	WS
Category	Earthen Levee			GPS Latitude/Longitude	
				Start	End
Item	Encroachments			38.668132 °	38.665528 °
				-121.438229 °	-121.431688 °
DWR ID	DWR_NA0001_08_s_2012_1				
Comment Code					
MA : Material					
Inspector Comment					
This portion is channel only, and there is no access for maintenance.

View looking downstream at inaccessible portion of Magpie Creek.
There is only channel maintenance in this section.

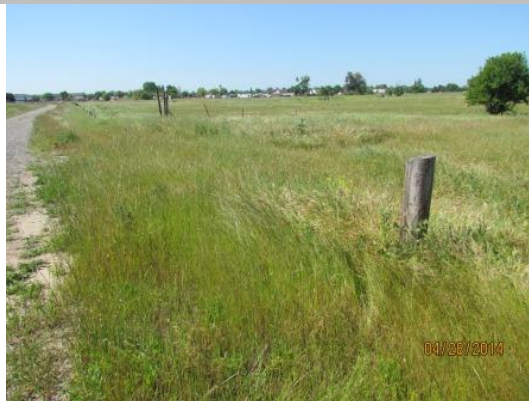
Photo 1 of 1 : SP_2019_NA0001_59_20_20190307_00012.jpg

LM Start	1.22	Rating **	M	Issue No.	20
LM End	1.22	Issue Type +	En	Location *	LS
Category	Earthen Levee			GPS Latitude/Longitude	
				Start	End
Item	Encroachments			38.662816 °	38.662816 °
				-121.431678 °	-121.431678 °
DWR ID	DWR_NA0001_08_s_2014_20				
Comment Code					
PO : Pole					
Inspector Comment

View of the pole on landside levee toe. Spring 2014

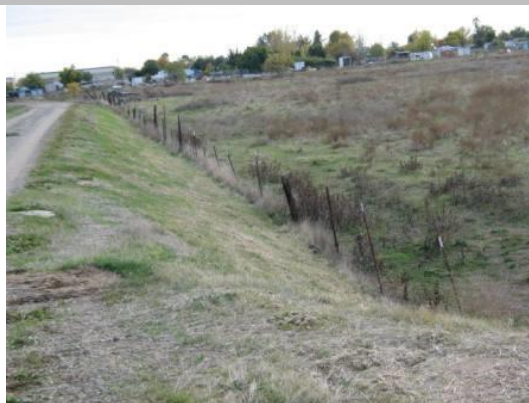
Photo 1 of 1 : SP_2019_NA0001_59_2_20190307_00002.jpg

LM Start	1.22	Rating **	M	Issue No.	2	
LM End	1.31	Issue Type +	En	Location *	LS	
Category	Earthen Levee			GPS Latitude/Longitude		
				Start		End
Item	Encroachments			38.662715 °		38.661584 °
				-121.431666 °		-121.431402 °
DWR ID	DWR_NA0001_08_s_2012_2					
Comment Code						
FE : Fence						
Inspector Comment						
Barbed wire fence runs along the levee toe.

11/17/2011 Barbed wire fence at levee toe.

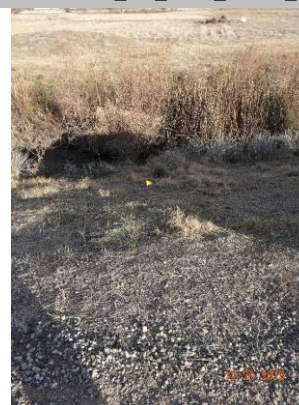
Photo 1 of 2 : UCIP_SP_2019_30689_56509.jpg

LM Start	1.28	Rating **	M	Issue No.	26
LM End	1.28	Issue Type +	En	Location *	
Category	Supplemental			GPS Latitude/Longitude	
				Start	End
Item	DWR UCIP Field Study			38.661843 °	38.661843 °
				-121.431675 °	-121.431675 °
DWR ID	24815				
Comment Code					
Inspector Comment					
FS_ID:30689					
DS_ID:24815					
EP_NO: N/A					
Repair Type: Non-Urgent					
Crossing Status: Indicator Found					
UCIP Comments: unable to confirm if conduit or gas line cross levee or flag identifying problem areas. Need additional information.					
FIELD_STRUCT_DESC: Underground service alert (USA) markers found on waterside (WS) and landside (LS) during field inspection.					
FS Date: 12/20/2013

View of waterward side.

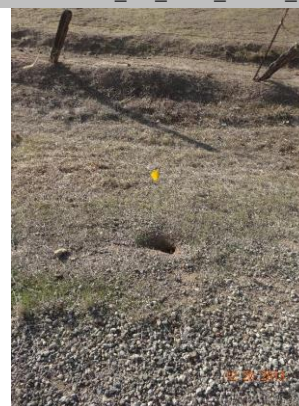
Photo 2 of 2 : UCIP_SP_2019_30689_56508.jpg

LM Start	1.28	Rating **	M	Issue No.	26 (cont)
LM End	1.28	Issue Type +	En	Location *	
Category	Supplemental			GPS Latitude/Longitude	
				Start	End
Item	DWR UCIP Field Study			38.661843 °	38.661843 °
				-121.431675 °	-121.431675 °
DWR ID	24815				
Comment Code					
Inspector Comment					
FS_ID:30689 DS_ID:24815 EP_NO: N/A Repair Type: Non-Urgent Crossing Status: Indicator Found UCIP Comments: unable to confirm if conduit or gas line cross levee or flag identifying problem areas. Need additional information. FIELD_STRUCT_DESC: Underground service alert (USA) markers found on waterside (WS) and landside (LS) during field inspection. FS Date: 12/20/2013

View of landward side.

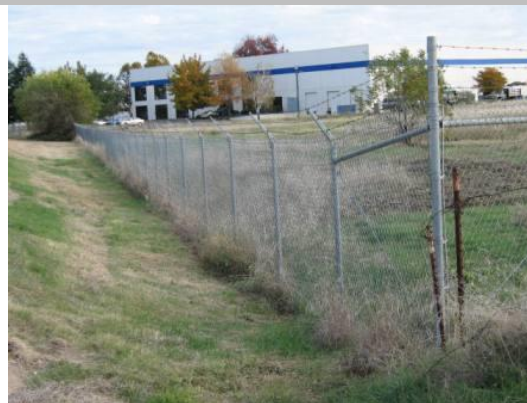
Photo 1 of 1 : SP_2019_NA0001_59_7_20190307_00005.jpg

LM Start	1.30	Rating **	M	Issue No.	7
LM End	1.33	Issue Type +	En	Location *	LS
Category	Earthen Levee			GPS Latitude/Longitude	
				Start	End
Item	Encroachments			38.661593 °	38.661370 °
				-121.431420 °	-121.430943 °
DWR ID	DWR_NA0001_08_s_2012_7				
Comment Code					
FE : Fence					
Inspector Comment					
Cyclone fence with barbed wire is within 10' of toe for part of its alignment.

11/17/2011 Chainlink fence at levee toe.

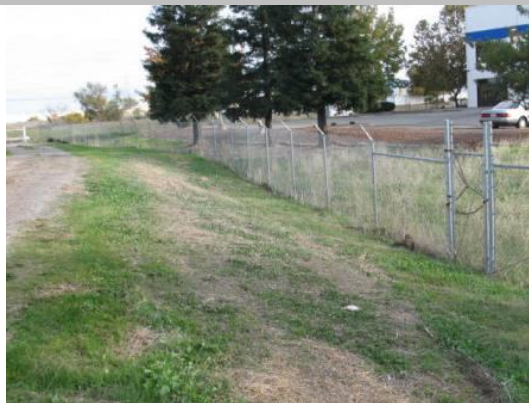
Photo 1 of 1 : SP_2019_NA0001_59_8_20190307_00006.jpg

LM Start	1.39	Rating **	M	Issue No.	8
LM End	1.43	Issue Type +	En	Location *	LS
Category	Earthen Levee			GPS Latitude/Longitude	
				Start	End
Item	Encroachments			38.660968 °	38.660828 °
				-121.430023 °	-121.429428 °
DWR ID	DWR_NA0001_08_s_2013_8				
Comment Code					
FE : Fence					
Inspector Comment					
Cyclone fence alignment returns to within 10' of toe.

11/17/2011 Chainlink fence alignment returns to the levee toe.

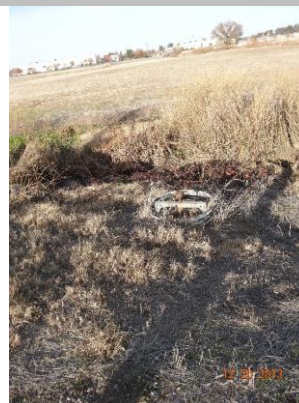
Photo 1 of 3 : UCIP_SP_2019_29329_54333.jpg

LM Start	1.40	Rating **	M	Issue No.	27	
LM End	1.40	Issue Type +	En	Location *		
Category	Supplemental			GPS Latitude/Longitude		
				Start	End	
Item	DWR UCIP Field Study			38.660913 °	38.660913 °	
				-121.429900 °	-121.429900 °	
DWR ID	24384

Comment Code						
Inspector Comment						
FS_ID:29329 DS_ID:24384 EP_NO: N/A Repair Type: Non-Urgent Crossing Status: Indicator Found UCIP Comments: Non-functional crossing--need to coordinate with owner, DWR-Inspector, and CVFPB to determine how to properly abandon crossing. FIELD_STRUCT_DESC: *ABANDONED* 24-inch corrugated metal (CM) pipe through the levee, 8 feet below the crown. Two CM cutoff walls around pipe. Slide gate in 30-inch CM riser and flap gate on waterside (WS) end. Concrete "U" headwall and splash apron on WS end. Landside (LS) end cutoff and plugged, riser filled with dirt. [Additional Reference(s): DWR Levee Log, 2002. USACE Sacramento O&M Manual Unit 118, Part No. 2, October 1959, Drawing No. 1-4-392 Exhibit B, (Station 72+10)] FS Date: 12/20/2013

View of riser with slide gate located on waterward side.

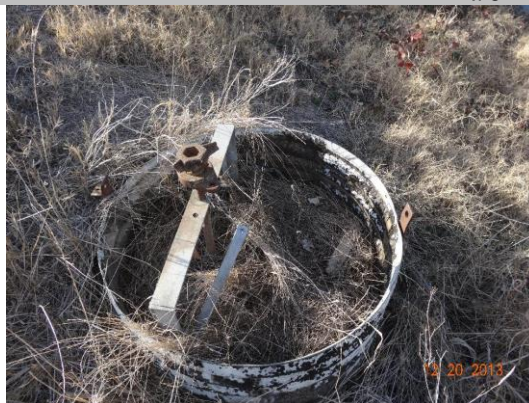
Photo 2 of 3 : UCIP_SP_2019_29329_54332.jpg

Comment Code						
Inspector Comment						
FS_ID:29329						
DS_ID:24384						
EP_NO: N/A						
Repair Type: Non-Urgent						
Crossing Status: Indicator Found						
UCIP Comments: Non-functional crossing--need to coordinate with owner, DWR-Inspector, and CVFPB to determine how to properly abandon crossing.						
FIELD_STRUCT_DESC: *ABANDONED* 24-inch corrugated metal (CM) pipe through the levee, 8 feet below the crown. Two CM cutoff walls around pipe. Slide gate in 30-inch CM riser and flap gate on waterside (WS) end. Concrete "U" headwall and splash apron on WS end. Landside (LS) end cutoff and plugged, riser filled with dirt.						
[Additional Reference(s): DWR Levee Log, 2002. USACE Sacramento O&M Manual Unit 118, Part No. 2, October 1959, Drawing No. 1-4-392 Exhibit B, (Station 72+10)]						
FS Date: 12/20/2013

Slide gate non-functional--riser filled with soil.

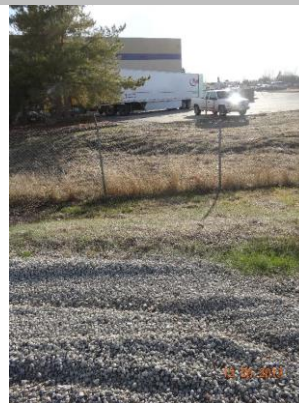
Photo 3 of 3 : UCIP_SP_2019_29329_54334.jpg

View of landward side.

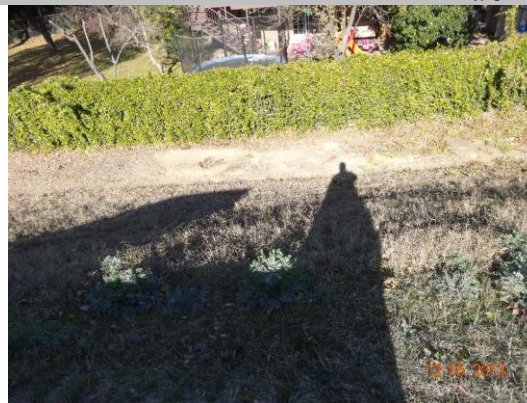
Photo 1 of 2 : UCIP_SP_2019_29347_54363.jpg

Comment Code						
Inspector Comment						
FS_ID:29347 DS_ID:24394 EP_NO: N/A Repair Type: Non-Urgent Crossing Status: Indicator Found UCIP Comments: 08/16/2017 DWR Deferred Maintenance Project (DMP), Vince Rodriguez, forwarded email received from Tim Kerr, General Manager of American River Flood Control District (ARFCD) with file "DWR Eligible Pipes Found in ARFCD" from ARFCD that shows the ownership and location of the pipes Tim Kerr investigated. No owner mentioned in email, ARFCD Staff Notes indicate riser in floodway near Beckenwood Way. (DWR UCIP - O. Magana) 12/05/2013 Need to contact owner to determine status of crossing. (DWR UCIP - O. Magana) FIELD_STRUCT_DESC: *Assumed ABANDONED* 12-inch steel pipe of unknown purpose through the levee, 14 feet below the crown. Riser unit on waterside (WS). (reference to 12-inch pipe scheduled to be abandoned (no clear direction of action taken available in permit recordation, see page 14 of 27 electronic permit copy) under Permit No. 4622, 1964 - County of Sacramento). [Additional Reference(s): DWR Levee Log, 2002. USACE Sacramento O&M Manual Unit 517, Part No. 1, November 1959, Drawing No. 1-4-0415, (Station 296+85)] FS Date: 12/5/2013

View of landward side.

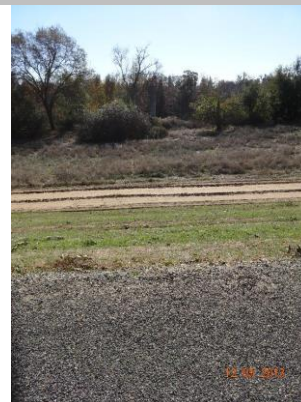
Photo 2 of 2 : UCIP_SP_2019_29347_54362.jpg

LM Start	1.29	Rating **	M	Issue No.	39 (cont)
LM End	1.29	Issue Type +	En	Location *

View of waterward side--tall riser located approximately 200 feet away.

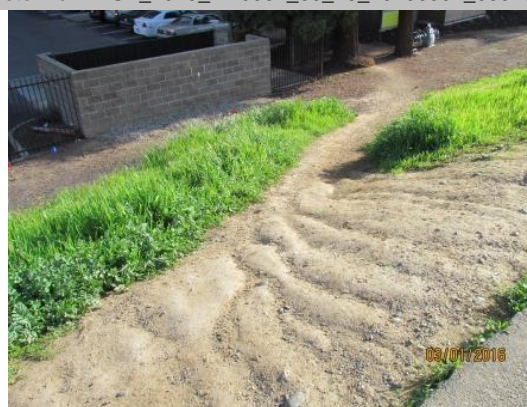
Photo 1 of 1 : SP_2019_NA0001_60_28_20190307_00010.jpg

LM Start	1.88	Rating **	M	Issue No.	28
LM End	1.88	Issue Type +	Ma	Location *	LS
Category	Earthen Levee			GPS Latitude/Longitude	
				Start	End
Item	Slope Stability			38.561171 °	38.561171 °
				-121.415808 °	-121.415808 °
DWR ID	DWR_NA0001_09_s_2016_28				
Comment Code					
S2 : Repair the levee slope damaged by foot traffic and prevent access where possible.					
Inspector Comment

View of the landside levee slope.

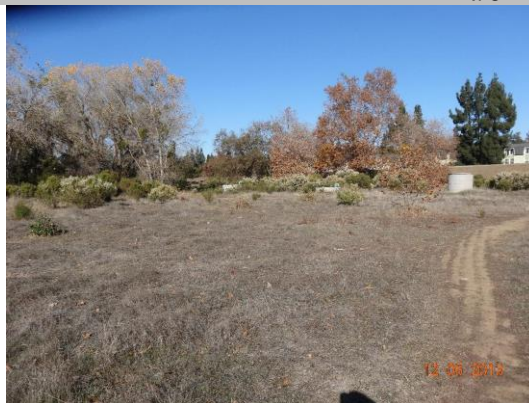
Photo 1 of 3 : UCIP_SP_2019_29351_54369.jpg

LM Start	1.93	Rating **	M	Issue No.	40
LM End	1.93	Issue Type +	En	Location *	
Category	Supplemental			GPS Latitude/Longitude	
				Start	End
Item	DWR UCIP Field Study			38.560889 °	38.560889 °
				-121.417196 °	-121.417196 °
DWR ID	24597				
Comment Code					
Inspector Comment					
FS_ID:29351 DS_ID:24597 EP_NO: 17587 Repair Type: Non-Urgent Crossing Status: Indicator Found UCIP Comments: Unable to confirm if riser belongs to this crossing--need to coordinate with owner to determine specifics. Description needs to be updated. FIELD_STRUCT_DESC: 54-inch water main of unknown material through the levee at unknown depth. (54-inch pipe authorized under Permit No. 17587, 2003-City of Sacramento) FS Date: 12/5/2013

Three risers located on waterward berm.

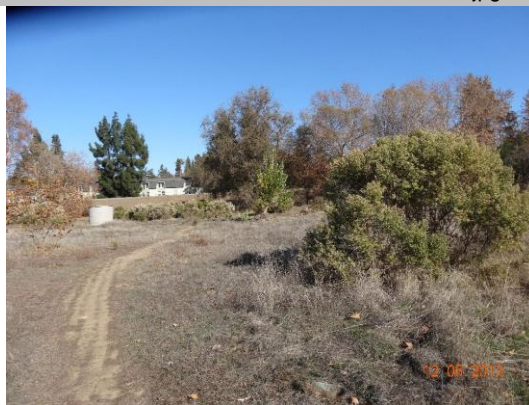
Photo 2 of 3 : UCIP_SP_2019_29351_54368.jpg

View of waterward berm looking toward levee crown from waterward berm edge.

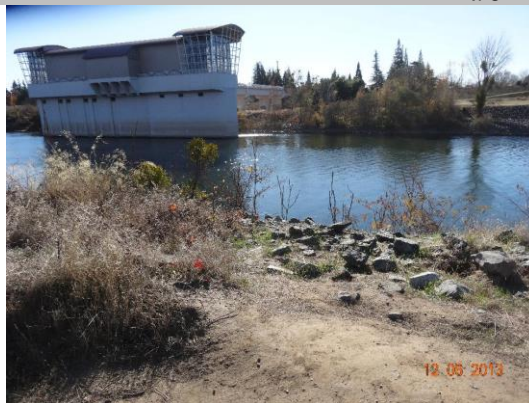
Photo 3 of 3 : UCIP_SP_2019_29351_54367.jpg

LM Start	1.93	Rating **	M	Issue No.	40 (cont)	
LM End	1.93	Issue Type +	En	Location *		
Category	Supplemental			GPS Latitude/Longitude		
				Start	End	
Item	DWR UCIP Field Study			38.560889 °	38.560889 °	
				-121.417196 °	-121.417196 °	
DWR ID	24597					
Comment Code						
Inspector Comment						
FS_ID:29351						
DS_ID:24597						
EP_NO: 17587						
Repair Type: Non-Urgent						
Crossing Status: Indicator Found						
UCIP Comments: Unable to confirm if riser belongs to this crossing--need to coordinate with owner to determine specifics. Description needs to be updated.						
FIELD_STRUCT_DESC: 54-inch water main of unknown material through the levee at unknown depth. (54-inch pipe authorized under Permit No. 17587, 2003-City of Sacramento)						
FS Date: 12/5/2013

View of waterward edge--rip rap armor along toe.

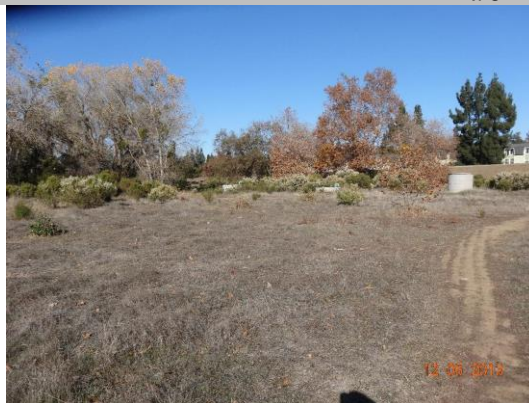
Photo 1 of 3 : UCIP_SP_2019_30124_55522.jpg

LM Start	1.95	Rating **	M	Issue No.	41
LM End	1.95	Issue Type +	En	Location *	
Category	Supplemental			GPS Latitude/Longitude	
				Start	End
Item	DWR UCIP Field Study			38.561064 °	38.561064 °
				-121.417323 °	-121.417323 °
DWR ID	24395				
Comment Code					
Inspector Comment					
FS_ID:30124					
DS_ID:24395					
EP_NO: N/A					
Repair Type: Non-Urgent					
Crossing Status: Indicator Found					
UCIP Comments: unable to confirm crossing--need to contact owner to determine status of crossing.					
FIELD_STRUCT_DESC: 60-inch sewer main through the American River overflow area. Erosion protection and rock revetment on waterside (WS) slope added under Permit No. 14487 (1986). [Additional Reference(s): DWR Levee Log, 2002]					
FS Date: 12/5/2013

View of berm on waterward side.

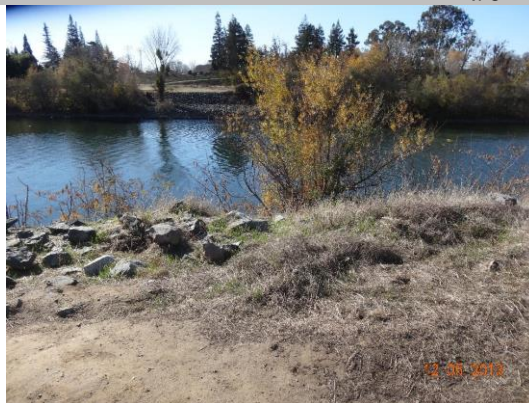
Photo 2 of 3 : UCIP_SP_2019_30124_55521.jpg

LM Start	1.95	Rating **	M	Issue No.	41 (cont)	
LM End	1.95	Issue Type +	En	Location *		
Category	Supplemental			GPS Latitude/Longitude		
				Start	End	
Item	DWR UCIP Field Study			38.561064 °	38.561064 °	
				-121.417323 °	-121.417323 °	
DWR ID	24395					
Comment Code						
Inspector Comment						
FS_ID:30124						
DS_ID:24395						
EP_NO: N/A						
Repair Type: Non-Urgent						
Crossing Status: Indicator Found						
UCIP Comments: unable to confirm crossing--need to contact owner to determine status of crossing.						
FIELD_STRUCT_DESC: 60-inch sewer main through the American River overflow area. Erosion protection and rock revetment on waterside (WS) slope added under Permit No. 14487 (1986). [Additional Reference(s): DWR Levee Log, 2002]						
FS Date: 12/5/2013

Rip rap used along waterward toe.

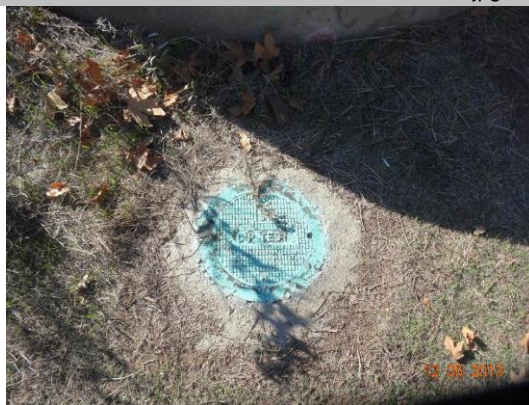
Photo 3 of 3 : UCIP_SP_2019_30124_55520.jpg

Small handhole found need concrete cylinder.

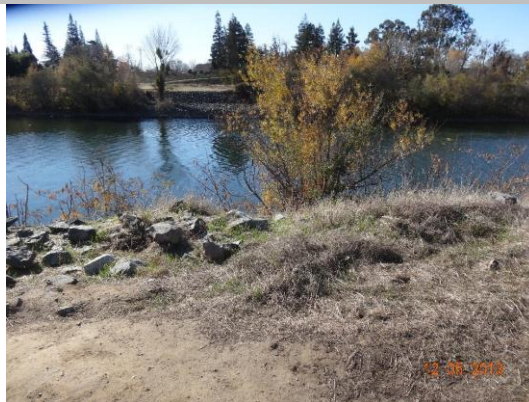
Photo 2 of 3 : UCIP_SP_2019_46085_54712.jpg

LM Start	1.96	Rating **	M	Issue No.	42
LM End	1.96	Issue Type +	En	Location *	
Category	Supplemental			GPS Latitude/Longitude	
				Start	End
Item	DWR UCIP Field Study			38.561119 °	38.561119 °
				-121.417581 °	-121.417581 °
DWR ID	24649				
Comment Code					
Inspector Comment					
FS_ID:46085 DS_ID:24649 EP_NO: 12188 Repair Type: Non-Urgent Crossing Status: Indicator Found UCIP Comments: unable to confirm crossing--need to contact owner to determine specifics and status of crossing. FIELD_STRUCT_DESC: 60-inch steel sewer main under the levee, approximately 21.6 feet below the crown. Two concrete cutoff walls around pipe under each shoulder. (60-inch pipe authorized under Permit No. 12188, 1979-Sacramento Regional County Sanitation District; erosion protection and rock revetment on waterside (WS) slope added under Permit No. 14487, 1986-). FS Date: 12/5/2013

View of waterward edge--rip rap used to armor toe.

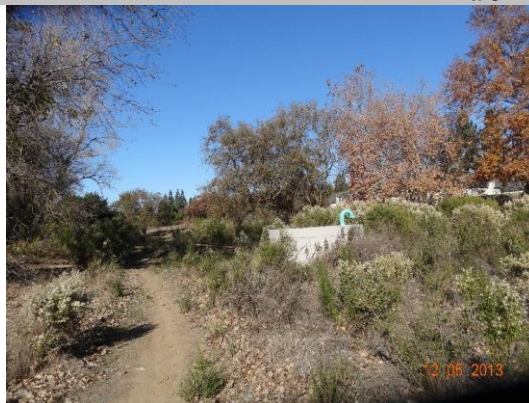
Photo 3 of 3 : UCIP_SP_2019_46085_54711.jpg

LM Start	1.96	Rating **	M	Issue No.	42 (cont)	
LM End	1.96	Issue Type +	En	Location *		
Category	Supplemental			GPS Latitude/Longitude		
				Start		End
Item	DWR UCIP Field Study			38.561119 °		38.561119 °
				-121.417581 °		-121.417581 °
DWR ID	24649					
Comment Code						
Inspector Comment						
FS_ID:46085 DS_ID:24649 EP_NO: 12188 Repair Type: Non-Urgent Crossing Status: Indicator Found UCIP Comments: unable to confirm crossing--need to contact owner to determine specifics and status of crossing. FIELD_STRUCT_DESC: 60-inch steel sewer main under the levee, approximately 21.6 feet below the crown. Two concrete cutoff walls around pipe under each shoulder. (60-inch pipe authorized under Permit No. 12188, 1979-Sacramento Regional County Sanitation District; erosion protection and rock revetment on waterside (WS) slope added under Permit No. 14487, 1986-). FS Date: 12/5/2013

View of second concrete cylinder located on waterward berm.

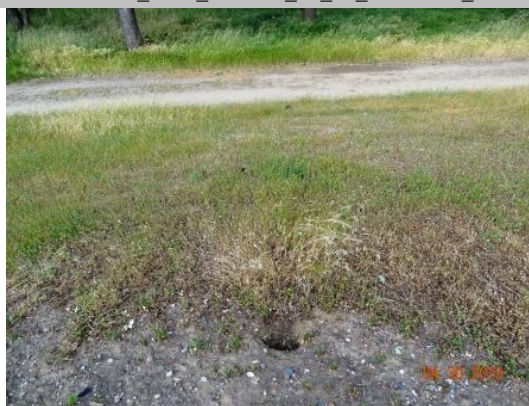
Photo 1 of 1 : SP_2019_NA0001_60_19_20190501_00046.jpg

LM Start	2.17	Rating **	A/W	Issue No.	19
LM End	2.17	Issue Type +	Ma	Location *	WS
Category	Earthen Levee			GPS Latitude/Longitude	
				Start	End
Item	Animal Control			38.563904 °	38.563904 °
				-121.419690 °	-121.419690 °
DWR ID	DWR_NA0001_09_f_2018_19				
Comment Code					
A3 : No rodents visible, but rodent burrows visible; need to backfill and compact or grout burrows.					
Inspector Comment					
Monitor rodent activity and backfill hole.

View of rodent hole on levee slope. Spring 2019

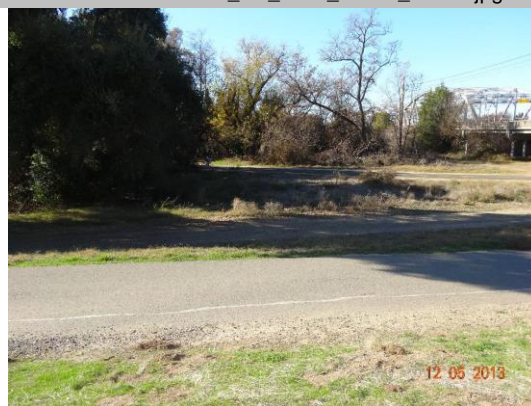
Photo 1 of 3 : UCIP_SP_2019_31309_57338.jpg

LM Start	2.51	Rating **	M	Issue No.	43
LM End	2.51	Issue Type +	En	Location *	
Category	Supplemental			GPS Latitude/Longitude	
				Start	End
Item	DWR UCIP Field Study			38.568767 °	38.568767 °
				-121.421178 °	-121.421178 °
DWR ID	24515				
Comment Code					
Inspector Comment					
FS_ID:31309					
DS_ID:24515					
EP_NO: N/A					
Repair Type: Non-Urgent					
Crossing Status: Indicator Found					
UCIP Comments: Unable to confirm crossing. will need to contact owner to determine specifics and status of crossing.					
FIELD_STRUCT_DESC: 36-inch corrugated metal (CM) drainage pipe through the levee at an unknown depth below the crown. Riser unit on waterside (WS). [Additional Reference(s): USACE Sacramento O&M Manual Unit 517, Part No. 1, November 1959, Drawing No. 1-4-0415, (Station 365+14)]					
FS Date: 12/5/2013

View of waterward side.

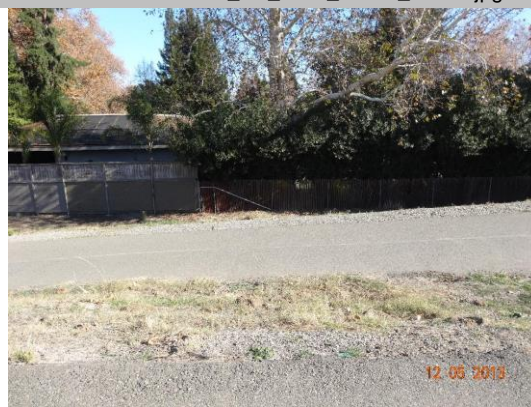
Photo 2 of 3 : UCIP_SP_2019_31309_57337.jpg

View of landward side.

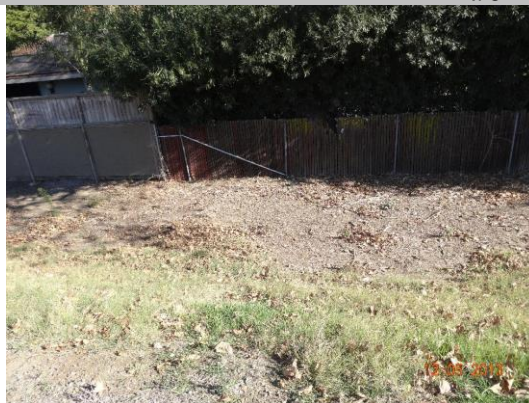
Photo 3 of 3 : UCIP_SP_2019_31309_57336.jpg

Landward side toe cleared.

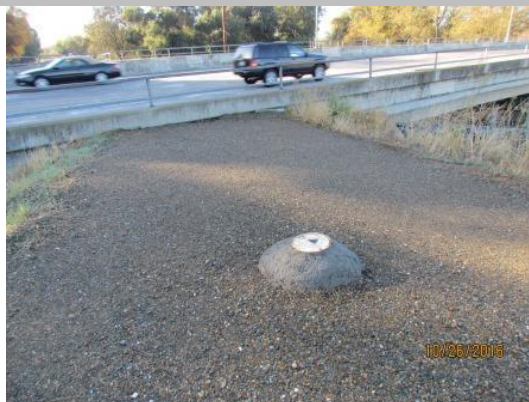
Photo 1 of 1 : SP_2019_NA0001_60_23_20190307_00006.jpg

LM Start	2.56	Rating **	U	Issue No.	23
LM End	2.56	Issue Type +	En	Location *	CR
Category	Earthen Levee			GPS Latitude/Longitude	
				Start	End
Item	Encroachments			38.569380 °	38.569380 °
				-121.421325 °	-121.421325 °
DWR ID	DWR_NA0001_09_f_2016_23				
Comment Code					
MW : Monitoring Well					
Inspector Comment					
Monitoring well does not meet Title 23 standards. Well should be flush with the levee crown.

View of the monitoring well on the levee crown.

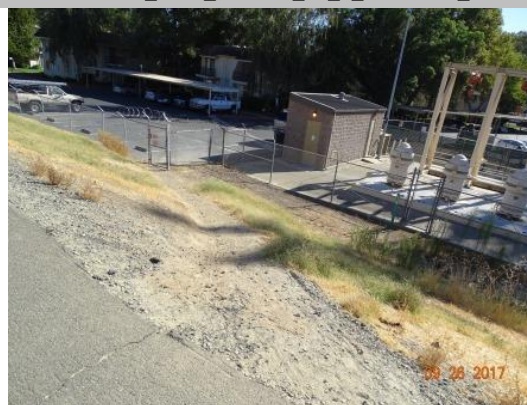
Photo 1 of 1 : SP_2019_NA0001_60_9_20190307_00004.jpg

LM Start	2.73	Rating **	A/W	Issue No.	9
LM End	2.73	Issue Type +	Ma	Location *	LS
Category	Earthen Levee			GPS Latitude/Longitude	
				Start	End
Item	Slope Stability			38.571868 °	38.571868 °
				-121.420605 °	-121.420605 °
DWR ID	DWR_NA0001_09_s_2018_9				
Comment Code					
S2 : Repair the levee slope damaged by foot traffic and prevent access where possible.					
Inspector Comment					
Footpath appears to be stable at this time but should be monitored for further erosion.

View of the footpath on the levee slope.

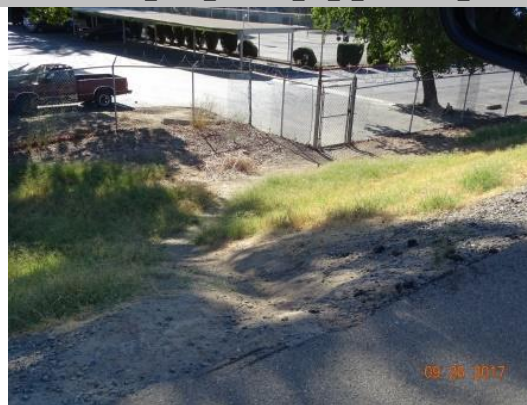
Photo 1 of 1 : SP_2019_NA0001_60_8_20190307_00003.jpg

LM Start	2.92	Rating **	M	Issue No.	8
LM End	2.92	Issue Type +	Ma	Location *	LS
Category	Earthen Levee			GPS Latitude/Longitude	
				Start	End
Item	Slope Stability			38.574474 °	38.574474 °
				-121.419734 °	-121.419734 °
DWR ID	DWR_NA0001_09_f_2017_8				
Comment Code					
S2 : Repair the levee slope damaged by foot traffic and prevent access where possible.					
Inspector Comment

View of the footpath on the levee slope.

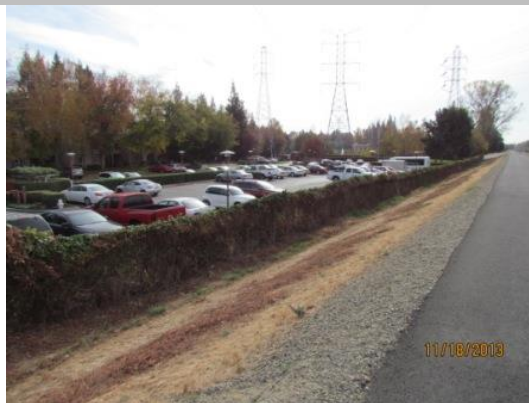
Photo 1 of 1 : SP_2019_NA0001_60_2_20190307_00002.jpg

LM Start	3.06	Rating **	U	Issue No.	2
LM End	3.19	Issue Type +	En	Location *	LS
Category	Earthen Levee			GPS Latitude/Longitude	
				Start	End
Item	Encroachments			38.576423 °	38.578248 °
				-121.419117 °	-121.418475 °
DWR ID	DWR_NA0001_09_s_2012_2				
Comment Code					
FE : Fence					
Inspector Comment

View of the trimmed vegetation on the chain linked fence still obstructing visibility.

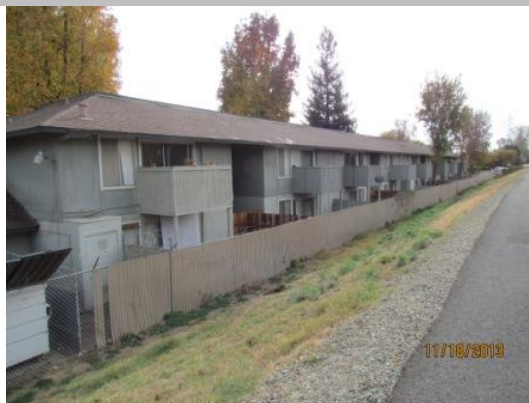
Photo 1 of 1 : SP_2019_NA0001_60_1_20190307_00001.jpg

LM Start	3.19	Rating **	U	Issue No.	1
LM End	3.27	Issue Type +	En	Location *	LS
Category	Earthen Levee			GPS Latitude/Longitude	
				Start	End
Item	Encroachments			38.578258 °	38.579363 °
				-121.418475 °	-121.418100 °
DWR ID	DWR_NA0001_09_s_2012_1				
Comment Code					
FE : Fence					
Inspector Comment

View of the fence at the landside levee toe.

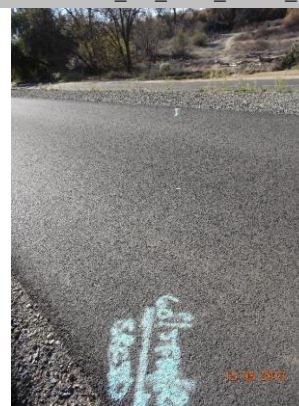
Photo 1 of 3 : UCIP_SP_2019_30125_55526.jpg

LM Start	3.32	Rating **	M	Issue No.	44
LM End	3.32	Issue Type +	En	Location *	
Category	Supplemental			GPS Latitude/Longitude	
				Start	End
Item	DWR UCIP Field Study			38.580094 °	38.580094 °
				-121.417821 °	-121.417821 °
DWR ID	24412				
Comment Code					
Inspector Comment					
FS_ID:30125 DS_ID:24412 EP_NO: 17671 Repair Type: Non-Urgent Crossing Status: Indicator Found UCIP Comments: unable to confirm if manhole is part of this crossing-- need to contact owner to determine status of crossing. FIELD_STRUCT_DESC: 1 of 2: 60-inch sewer main under the levee. Connects to 60-inch main on landside (LS). (two 60-inch force mains authorized under Permit No. 17671, 2003-Sacramento Regional County Sanitation District) FS Date: 12/5/2013

View of waterward side.

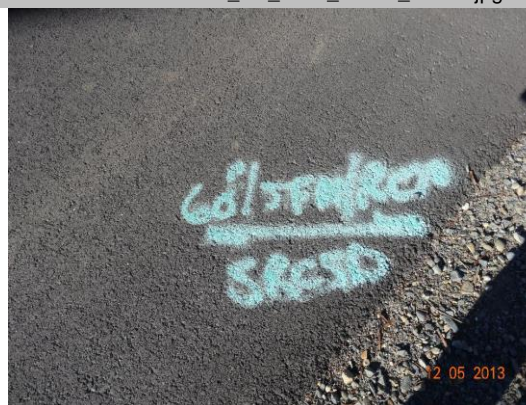
Photo 2 of 3 : UCIP_SP_2019_30125_55528.jpg

Underground service alert (USA) paint found on bike path on waterward side.

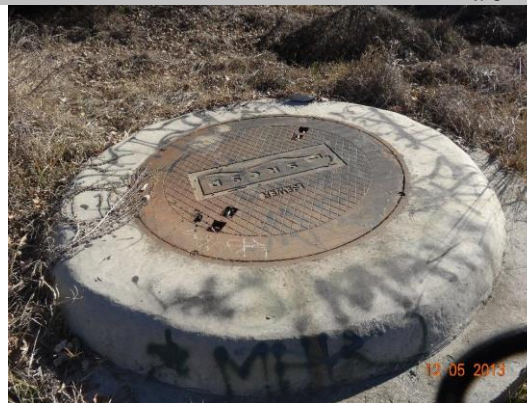
Photo 3 of 3 : UCIP_SP_2019_30125_55529.jpg

Manhole visible on waterward toe.

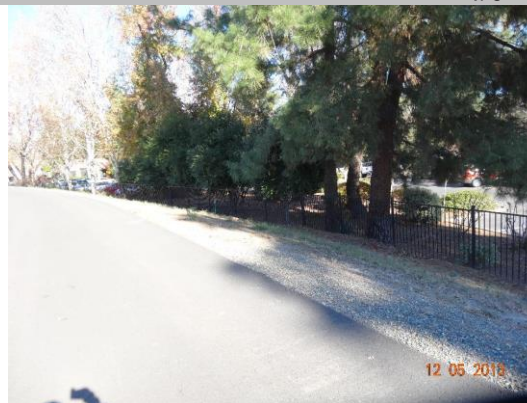
Photo 1 of 3 : UCIP_SP_2019_29633_54791.jpg

Comment Code					
Inspector Comment					
FS_ID:29633 DS_ID:24404 EP_NO: 12188 Repair Type: Non-Urgent Crossing Status: Indicator Found UCIP Comments: unable to confirm if crossing is still active--need to contact owner to determine status of crossing. FIELD_STRUCT_DESC: 60-inch concrete encased steel sewer line through the levee, 17.0 feet below the crown. Cutoff wall around pipe at the center of the levee. Rock revetment on waterside (WS) slope. Three pressure manholes in overflow area along pipe path. (60-inch force main sewerline authorized under Permit No. 12188, 1979-Sacramento Regional County Sanitation District) [Additional Reference(s): DWR Levee Log, 2002] FS Date: 12/5/2013

View of landward side.

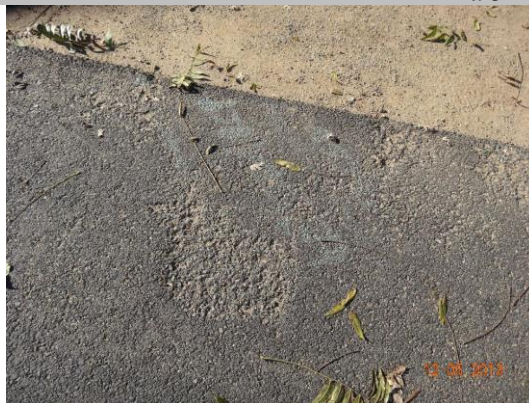
Photo 2 of 3 : UCIP_SP_2019_29633_54790.jpg

Underground service alert (USA) markings still present on levee crown.

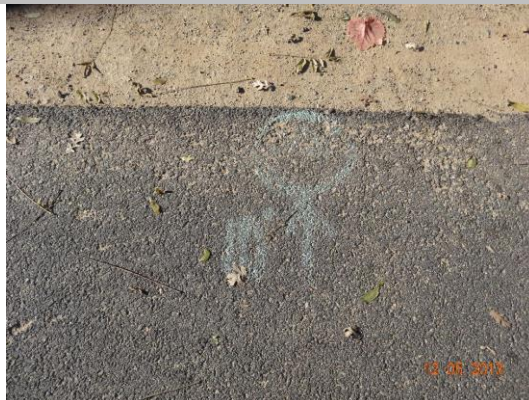
Photo 3 of 3 : UCIP_SP_2019_29633_54789.jpg

Faded paint markings located on levee crown.

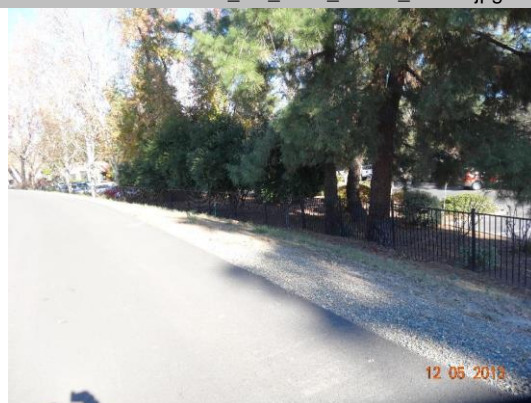
Photo 1 of 3 : UCIP_SP_2019_41437_55532.jpg

LM Start	3.34	Rating **	M	Issue No.	46	
LM End	3.34	Issue Type +	En	Location *		
Category	Supplemental			GPS Latitude/Longitude		
				Start	End	
Item	DWR UCIP Field Study			38.580435 °	38.580435 °	
				-121.417711 °	-121.417711 °	
DWR ID	24566					
Comment Code						
Inspector Comment						
FS_ID:41437						
DS_ID:24566						
EP_NO: 17671						
Repair Type: Non-Urgent						
Crossing Status: Indicator Found						
UCIP Comments: Need to confirm location with owner.						
FIELD_STRUCT_DESC: 2 of 2: 60-inch sewer main under the levee.						
Connects to 60-inch main on landside (LS). (two 60-inch force mains						
authorized under Permit No. 17671, 2003-Sacramento Regional County						
Sanitation District)						
FS Date: 12/5/2013

Overview of landward side.

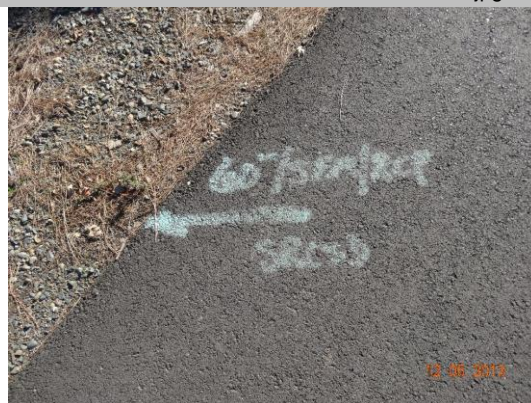
Photo 2 of 3 : UCIP_SP_2019_41437_55531.jpg

Underground service alert (USA) markings found on levee crown for 60-inch pipe.

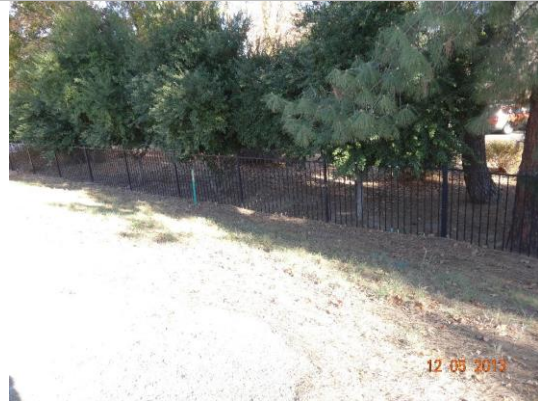
Photo 3 of 3 : UCIP_SP_2019_41437_55530.jpg

Marker visible on landward.

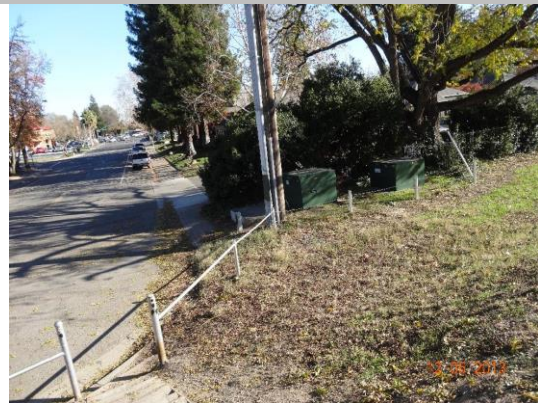
Photo 1 of 2 : UCIP_SP_2019_30684_56473.jpg

LM Start	3.42	Rating **	M	Issue No.	47
LM End	3.42	Issue Type +	En	Location *	
Category	Supplemental			GPS Latitude/Longitude	
				Start	End
Item	DWR UCIP Field Study			38.581572 °	38.581572 °
				-121.417819 °	-121.417819 °
DWR ID	24816				
Comment Code					
Inspector Comment					
FS_ID:30684 DS_ID:24816 EP_NO: N/A Repair Type: Non-Urgent Crossing Status: Indicator Found UCIP Comments: unable to determine if crossing goes through levee. Need to obtain additional information to confirm crossing. FIELD_STRUCT_DESC: Water fountain found on waterside (WS). FS Date: 12/5/2013

View of landward side.

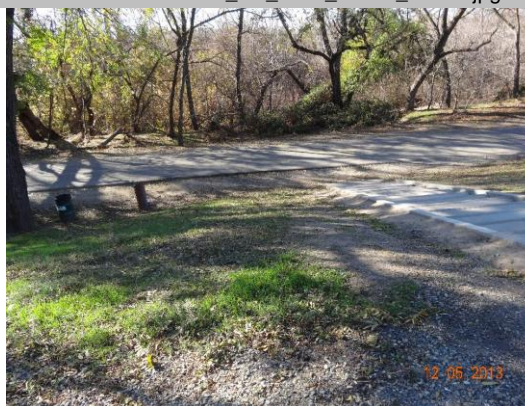
Photo 2 of 2 : UCIP_SP_2019_30684_56472.jpg

View of waterward side.

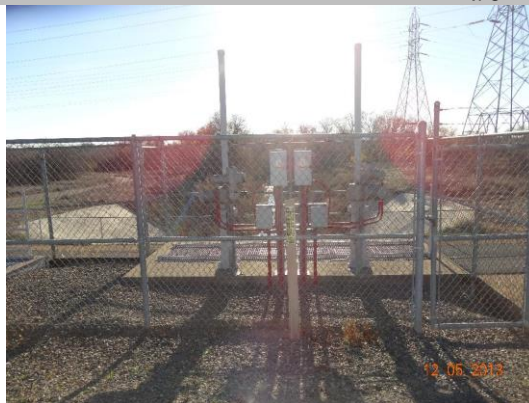
Photo 1 of 3 : UCIP_SP_2019_31304_57325.jpg

Comment Code					
Inspector Comment					
FS_ID:31304 DS_ID:24817 EP_NO: N/A Repair Type: Non-Urgent Crossing Status: Found UCIP Comments: 08/16/2017 DWR Deferred Maintenance Project (DMP), Vince Rodriguez, forwarded email received from Tim Kerr, General Manager of American River Flood Control District (ARFCD) with file "DWR Eligible Pipes Found in ARFCD" from ARFCD that shows the ownership and location of the pipes Tim Kerr investigated. Owner of this crossing is identified as the County of Sacramento, ARFCD Staff Notes indicate D-05 Upstream end of detention basin. (DWR UCIP - O. Magana) 12/05/2013 Need to confirm crossing size--need additional information about crossing. (DWR UCIP - O. Magana) FIELD_STRUCT_DESC: 1 of 2: Crossing through levee at unknown depth. Concrete structure (7-foot by 15-foot) located on waterside (WS) shoulder with slide gate inside manhole. Square flap gate located on WS end. Concrete wings and apron at WS end of outlet channel. Concrete box located on the WS shoulder fenced off. (no permit has been identified authorizing this structure, structure is owned by the County of Sacramento) FS Date: 12/5/2013

Concrete box and electrical box located on waterward shoulder.

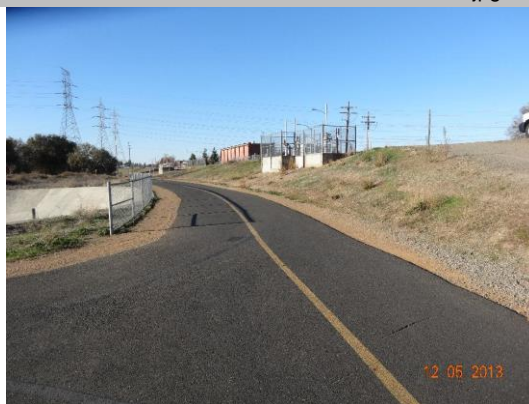
Photo 2 of 3 : UCIP_SP_2019_31304_57320.jpg

Bike path located on waterward side.

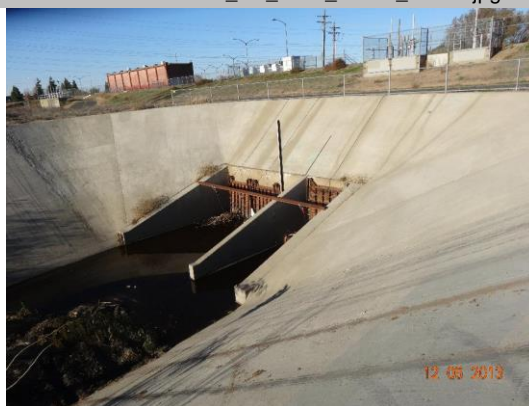
Photo 3 of 3 : UCIP_SP_2019_31304_57324.jpg

Concrete wall and wing walls located on waterward side.

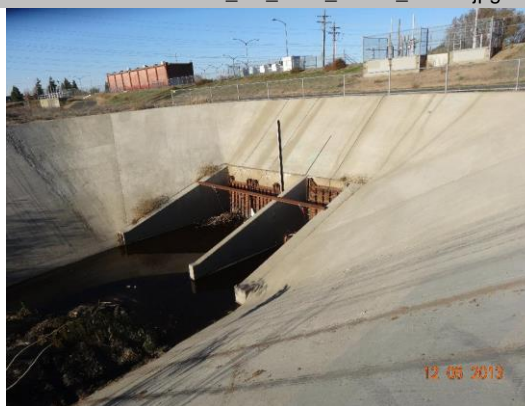
Photo 3 of 3 : UCIP_SP_2019_31306_57332.jpg

Comment Code						
Inspector Comment						
FS_ID:31306 DS_ID:24818 EP_NO: N/A Repair Type: Non-Urgent Crossing Status: Found UCIP Comments: 08/16/2017 DWR Deferred Maintenance Project (DMP), Vince Rodriguez, forwarded email received from Tim Kerr, General Manager of American River Flood Control District (ARFCD) with file "DWR Eligible Pipes Found in ARFCD" from ARFCD that shows the ownership and location of the pipes Tim Kerr investigated. Owner of this crossing is identified as the County of Sacramento, ARFCD Staff Notes indicate D-05 Upstream end of detention basin. (DWR UCIP - O. Magana) 12/05/2013 Unable to confirm pipe size--need additional information about crossing. (DWR UCIP - O. Magana) FIELD_STRUCT_DESC: 2 of 2: Crossing through levee at unknown depth. Concrete structure (7-foot by 15-foot) located on waterside (WS) shoulder with slide gate inside manhole. Square flap gate located on WS end. Concrete wings and apron at WS end of outlet channel. Concrete box located on the WS shoulder fenced off. (no permit has been identified authorizing this structure, structure is owned by the County of Sacramento) FS Date: 12/5/2013

Concrete headwall located on waterward toe.

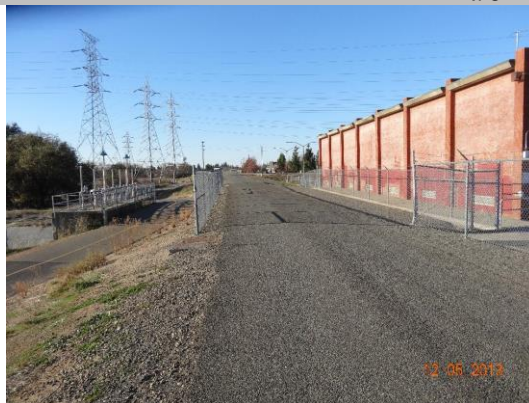
Photo 1 of 2 : UCIP_SP_2019_31307_57335.jpg

LM Start	3.72	Rating **	M	Issue No.	50	
LM End	3.72	Issue Type +	En	Location *		
Category	Supplemental			GPS Latitude/Longitude		
				Start	End	
Item	DWR UCIP Field Study			38.584710 °	38.584710 °	
				-121.421496 °	-121.421496 °	
DWR ID	24819					
Comment Code						
Inspector Comment						
FS_ID:31307						
DS_ID:24819						
EP_NO: N/A						
Repair Type: Non-Urgent						
Crossing Status: Found						
UCIP Comments: Unable to confirm is pipe crosses levee--no permit available.						
FIELD_STRUCT_DESC: Service box located on waterside (WS) and landside (LS). Unable to confirm crossing exists through levee. No permit found for this potential crossing.						
FS Date: 12/5/2013

View of concrete service box located on waterward shoulder.

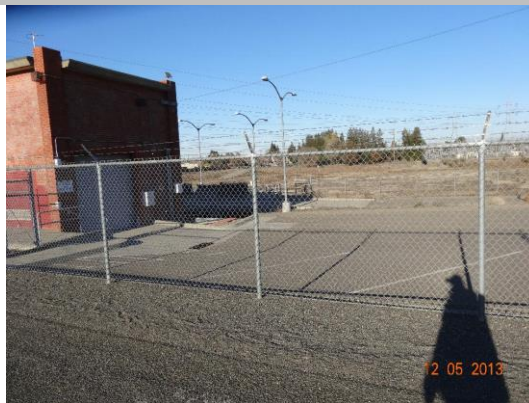
Photo 2 of 2 : UCIP_SP_2019_31307_57334.jpg

Concrete box located inside fenced area located on landward side.

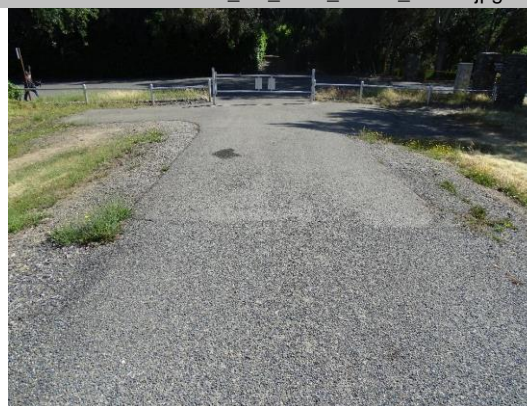
Photo 3 of 3 : UCIP_SP_2019_54053_79310.jpg

Comment Code						
Inspector Comment						
FS_ID:54053 DS_ID:24820 EP_NO: N/A Repair Type: Non-Urgent Crossing Status: Indicator Found UCIP Comments: 05/13/2019 Gas line appears to cross the levee; however, no permit has been found for this crossing. (A. McDonald - DWR UCIP)08/11/2017 PG&E records for this distribution main indicate that there were no leaks found on the 05/2015 leak survey and the pipeline is operating correctly according to the 12/2016 CP inspection. (DWR UCIP - A. McDonald)Unable to determine alignment of crossing, does it cross levee? Permit? FIELD_STRUCT_DESC: Protective posts located on landside (LS) for what appears to be for gas/petroleum line. Pipeline goes through levee and runs parallel. No permit found. In case of an emergency related to this pipeline, PG&E has identified the following contacts: PG&E's local pipeline engineer, Mike Aronoff at 916-307-9472 (cell), and Gas Control (north) at 800-442-4743. For non-emergency issues, please contact the local PG&E Gas Pipeline Operations and Maintenance (GPOM) supervisors for the Sacramento region, David Wade at 209-639-1039 (cell), or Ron Hicks at 916-396-9038 (cell). FS Date: 5/13/2019 11:54:00 AM

View of crown.

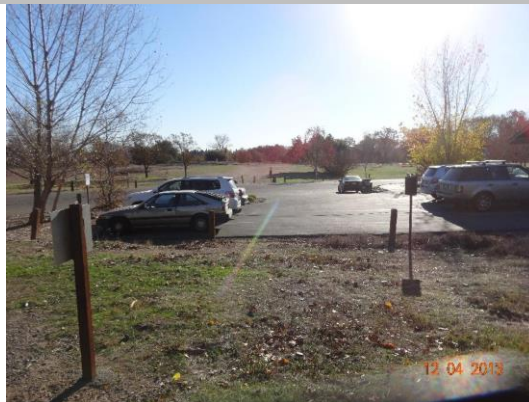
Photo 2 of 3 : UCIP_SP_2019_54054_47432.jpg

View of waterward side.

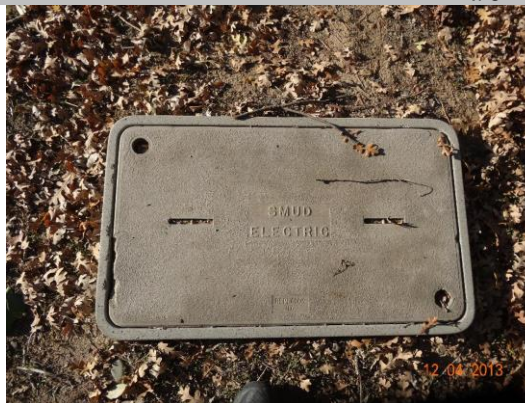
Photo 3 of 3 : UCIP_SP_2019_54054_47434.jpg

Comment Code						
Inspector Comment						
FS_ID:54054 DS_ID:24417 EP_NO: 1774 Repair Type: Non-Urgent Crossing Status: Indicator Found UCIP Comments: 05/13/2019 Permit indicates that telephone lines cross the levee; however, there is a conduit box that says, "SMUD ELECTRIC," on it. (A. McDonald - DWR UCIP) FIELD_STRUCT_DESC: Twelve 3.5-inch communications conduits sleeved through a single 36-inch steel pipe through the levee. Internal gaps grouted. Manhole at the landside (LS) toe. Headwalls on each end of pipe. (36-inch pipe with twelve 3.5-inch authorized under Permit No. 1774, 1953-Pacific Telephone and Telegraph Company) FS Date: 5/13/2019 11:58:00 AM

Conduit box located on landward side.

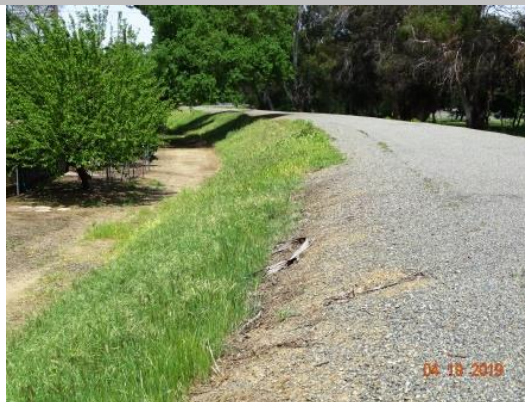
Photo 1 of 1 : SP_2019_NA0001_61_20_20190422_00047.jpg

LM Start	0.63	Rating **	A	Issue No.	20
LM End	0.63	Issue Type +	Ma	Location *	LS
Category	Earthen Levee			GPS Latitude/Longitude	
				Start	End
Item	Vegetation			38.592035 °	38.592035 °
				-121.334450 °	-121.334450 °
DWR ID	DWR_NA0001_10_s_2019_20				
Comment Code					
V1 : Control annual grass and weeds on the levee slopes and easements.					
Inspector Comment					
Annual vegetation is well-maintained.

View looking upstream at well-maintained landside vegetation. Spring 2019

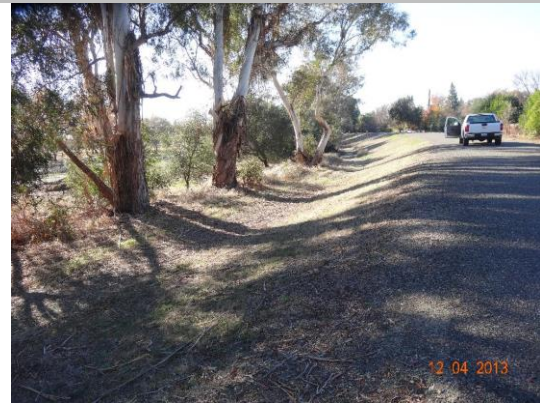
Photo 1 of 3 : UCIP_SP_2019_54055_47492.jpg

Comment Code						
Inspector Comment						
FS_ID:54055 DS_ID:24464 EP_NO: 12725 Repair Type: Non-Urgent Crossing Status: Indicator Found UCIP Comments: 05/13/2019 Permit indicates that there is a water pipe here; however, the well that used to be on the landside is now gone. (A. McDonald - DWR UCIP)Unable to confirm if this crossing is the same under permit 12725. Drinking fountain and water flow prevention located on waterward side. Need to coordinate with American River Flood Control District. FIELD_STRUCT_DESC: 6-inch steel water pipe through the levee, 2.5 feet below the crown. Arcade Water District well at landside (LS) toe. Well is gone (2019): Just a concrete pad, a fence, and a Christy box remain. Water valves, a hitchrack, and a drinking trough for horses on the waterside (WS). (6-inch pipe authorized under Permit No. 12725, 1980-County of Sacramento Department of Parks and Recreation) FS Date: 5/13/2019 11:58:00 AM

View of waterward slope.

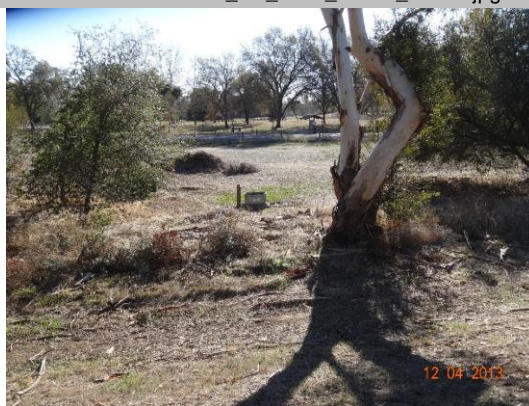
Photo 2 of 3 : UCIP_SP_2019_54055_47493.jpg

Comment Code						
Inspector Comment						
FS_ID:54055 DS_ID:24464 EP_NO: 12725 Repair Type: Non-Urgent Crossing Status: Indicator Found UCIP Comments: 05/13/2019 Permit indicates that there is a water pipe here; however, the well that used to be on the landside is now gone. (A. McDonald - DWR UCIP)Unable to confirm if this crossing is the same under permit 12725. Drinking fountain and water flow prevention located on waterward side. Need to coordinate with American River Flood Control District. FIELD_STRUCT_DESC: 6-inch steel water pipe through the levee, 2.5 feet below the crown. Arcade Water District well at landside (LS) toe. Well is gone (2019): Just a concrete pad, a fence, and a Christy box remain. Water valves, a hitchrack, and a drinking trough for horses on the waterside (WS). (6-inch pipe authorized under Permit No. 12725, 1980-County of Sacramento Department of Parks and Recreation) FS Date: 5/13/2019 11:58:00 AM

View of faucet located on waterward side.

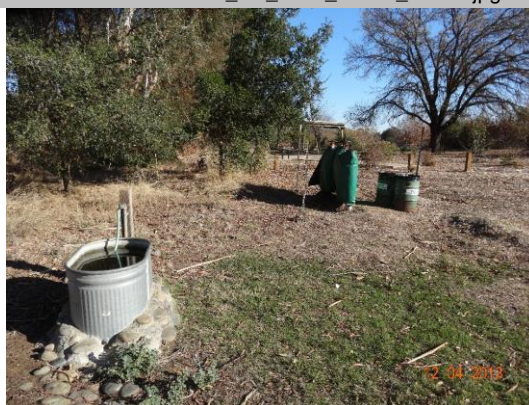
Photo 3 of 3 : UCIP_SP_2019_54055_47491.jpg

View of waterward side--faucet and water flow prevention system.

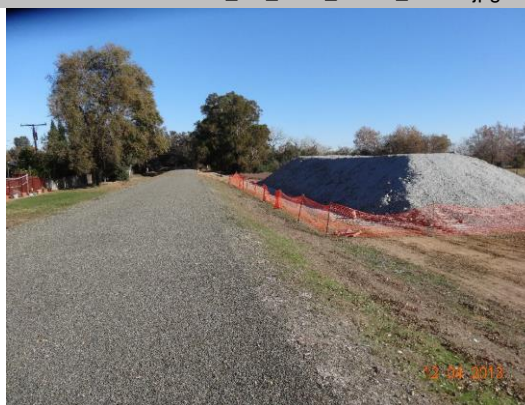
Photo 1 of 3 : UCIP_SP_2019_54058_57285.jpg

LM Start	1.04	Rating **	M	Issue No.	55
LM End	1.04	Issue Type +	En	Location *	
Category	Supplemental			GPS Latitude/Longitude	
				Start	End
Item	DWR UCIP Field Study			38.586813 °	38.586813 °
				-121.337643 °	-121.337643 °
DWR ID	24821				
Comment Code					
Inspector Comment					
FS_ID:54058					
DS_ID:24821					
EP_NO: N/A					
Repair Type: Non-Urgent					
Crossing Status: Indicator Found					
UCIP Comments: 05/13/2019 Field discovered. No permit. Conduit box on the WS. Unable to determine if this is a crossing. (A. McDonald - DWR UCIP)Unable to determine reason for box and whether there is a utility that crosses levee. No permit found.					
FIELD_STRUCT_DESC: Service box located on waterside (WS). No permit found.					
FS Date: 5/13/2019 12:00:00 PM

Overview of levee crown at crossing.

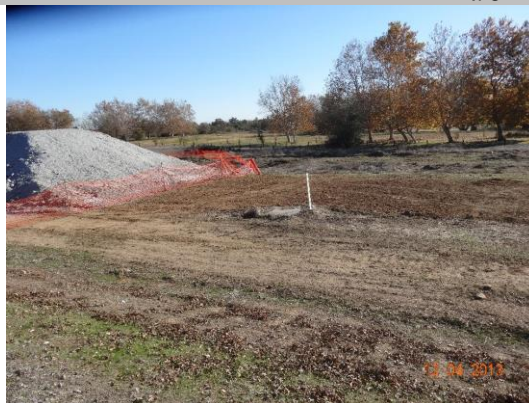
Photo 2 of 3 : UCIP_SP_2019_54058_57286.jpg

LM Start	1.04	Rating **	M	Issue No.	55 (cont)	
LM End	1.04	Issue Type +	En	Location *		
Category	Supplemental			GPS Latitude/Longitude		
				Start	End	
Item	DWR UCIP Field Study			38.586813 °	38.586813 °	
				-121.337643 °	-121.337643 °	
DWR ID	24821					
Comment Code						
Inspector Comment						
FS_ID:54058						
DS_ID:24821						
EP_NO: N/A						
Repair Type: Non-Urgent						
Crossing Status: Indicator Found						
UCIP Comments: 05/13/2019 Field discovered. No permit. Conduit box on the WS. Unable to determine if this is a crossing. (A. McDonald - DWR UCIP)Unable to determine reason for box and whether there is a utility that crosses levee. No permit found.						
FIELD_STRUCT_DESC: Service box located on waterside (WS). No permit found.						
FS Date: 5/13/2019 12:00:00 PM

Concrete vault located on waterward side.

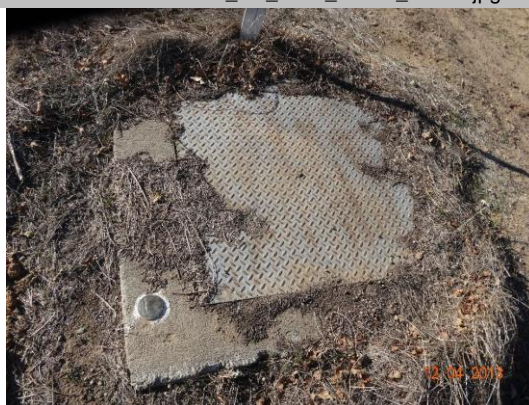
Photo 3 of 3 : UCIP_SP_2019_54058_57288.jpg

Close up of concrete box located on waterward side.
